xxxx 2020
CBAxxxx v1

PICUS SONIC
TOMOGRAPHY
INVESTIGATION
REPORT

- 1.1 CBA Trees was instructed by xxxx to undertake a Visual Tree Assessment (VTA) of one Pedunculate Oak (*Quercus robur*) tree that grows in the rear garden space.

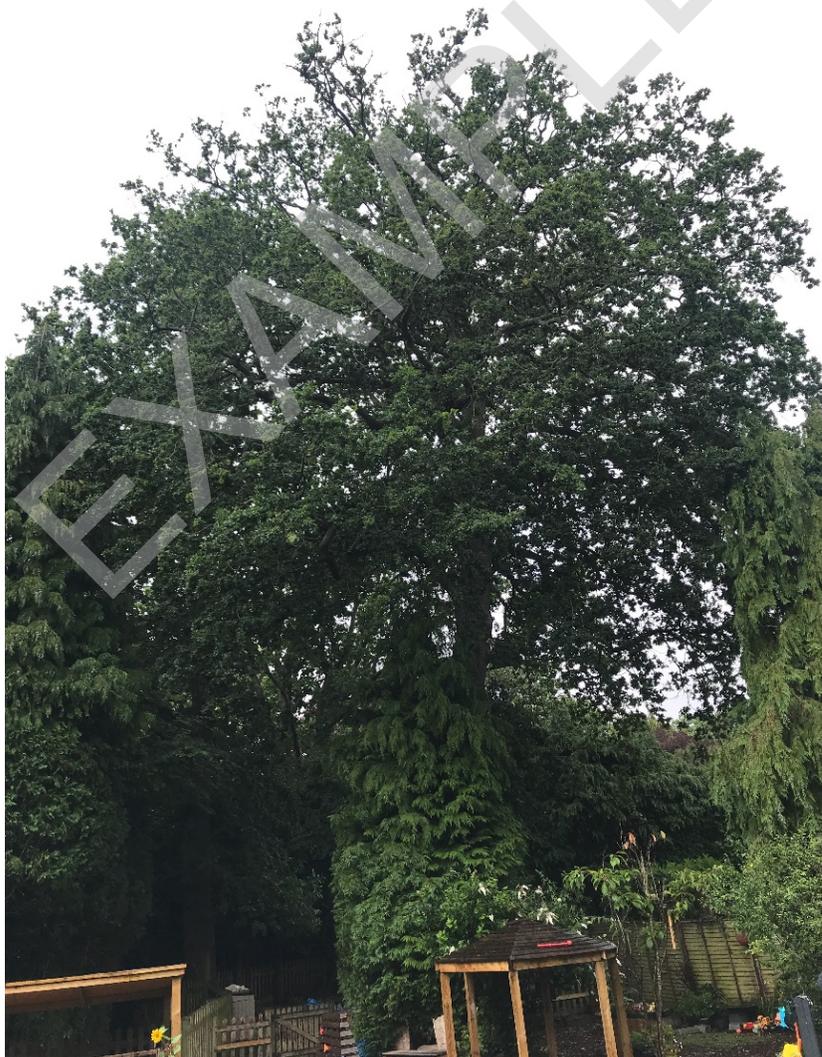
Photograph 1:

Showing the Oak from the eastern side

The crown of the Oak is weighted and bias towards the east due to surrounding trees and the Oak growing towards the light to maximise the photosynthetic capability of the tree.

The extension growth and bud development appeared to be in a good to fair condition in terms of the amount of growth rate of the tree in the lower crown. However in the upper crown, dieback and poor extension growth was present which suggests that the tree is under stress.

At the time of the inspection there were large (>50mm) dead branches within the crown which one would expect of a tree of this size and age.

- 5.6 An option in the longer term maybe to consider reducing the height of the tree and shorten the lateral spread by 2.0m, subject to Local Authority approval due to the legal protection afforded to this tree. However, this would not remove or control the symptoms at the base of the tree but allow the tree to potentially be retained for longer given the indicative signs of stress and decline with the minor dieback in the crown.

- 5.7 The Oak will need the deadwood removed from the crown if the tree is retained and this should be removed as soon as reasonably practical and could be completed at the same time the tree works at the site frontage are being carried out as the removal of deadwood does not need consent from the Local Authority just a polite notification of the intention to remove the wood prior to the work commencing.

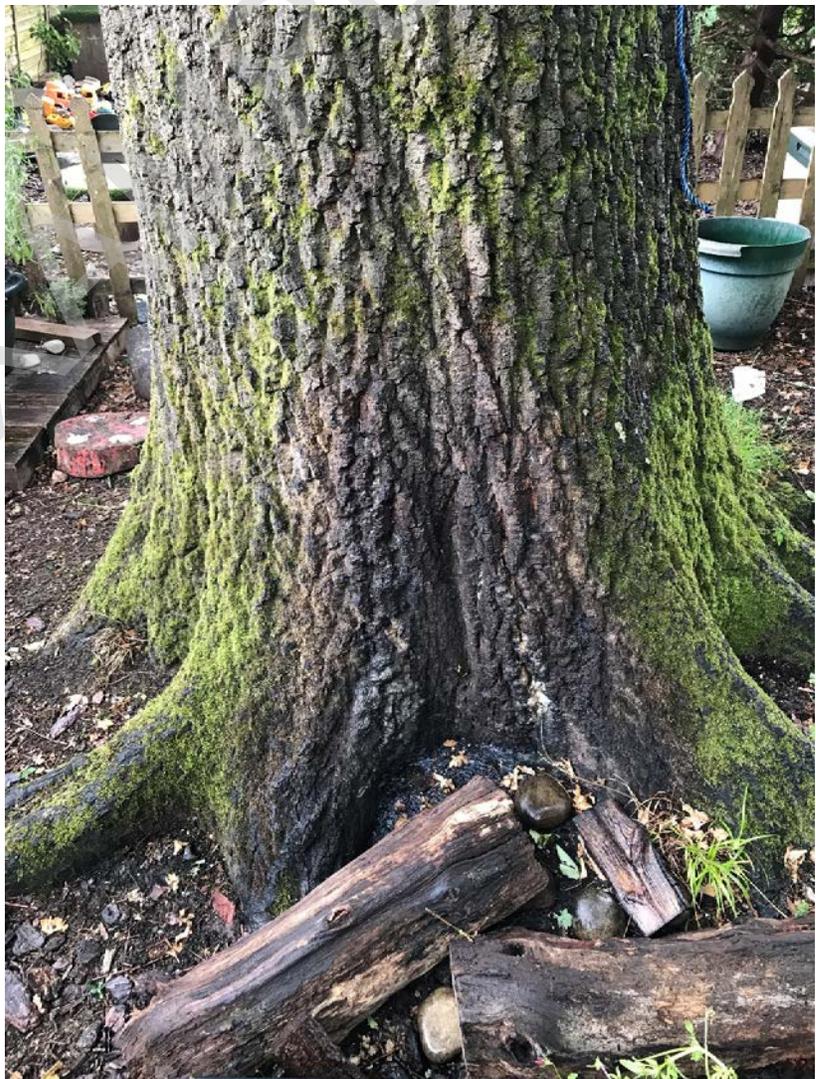
There is an area of wounding at the base of the trunk on the south west side measuring approximately 450mm wide and 800mm high. From this wound, a frothy, slime exudate was evident with a strong smell of stale alcohol. These signs indicate that the Oak has what is known as Frothy Oak Disease.

Photograph 2:
Showing the area of wounding on the south west side of the trunk

The froth is a result of wild yeasts infecting sugar rich sap seeping from damaged bark. The cause of the damage can vary from localised bark killing by fungi such as Honey Fungus to simple bark cracks. The frothy slime is different to bacterial wetwood as the frothing is considered to be relatively superficial within the bark and cambial region and persists, generally for a short period of time in the summer.*

5.3 The wounding at the base of the Oak appears to be superficial and with the evidence available at the time of this report, it is therefore our opinion that the tree does not require felling at this time.

- 5.4 Currently, the concern for this tree is not that the tree will collapse in part or in whole but will continue to show signs of dieback and decline along with the nuisance factor of insects being attracted to the sugary froth.

- Whilst the Oak is already fenced off from the main area of use this will reduce the likelihood of any persons being stung by insects that are attracted to the sugary froth. To further reduce the opportunity of insect stings and enabling a higher use of this area, washing down the froth during the summer months as required should remove or reduce the attraction of the surgery solution to insects. Specialist insect attractant traps could also be used if required.

- Symptoms of Frothy Oak Disease usually occur after a period of hot, dry weather, so water the tree deeply during these dry spells. Apply the water slowly to encourage absorption to a depth of 450 to 600mm. Water the entire area under the canopy of the tree.

- Cover the ground beneath the crown with a 75mm depth of mulch to aid in water retention.
 - Removing the dead patches of bark will allow better air flow around the wound and give the tree an opportunity to produce wound wood. Whilst the tree is most likely too old to fully occlude the wound, giving the tree the opportunity to produce this new wood, give the area of wounding a chance to dry may reduce the frequency or rate of the froth produced.

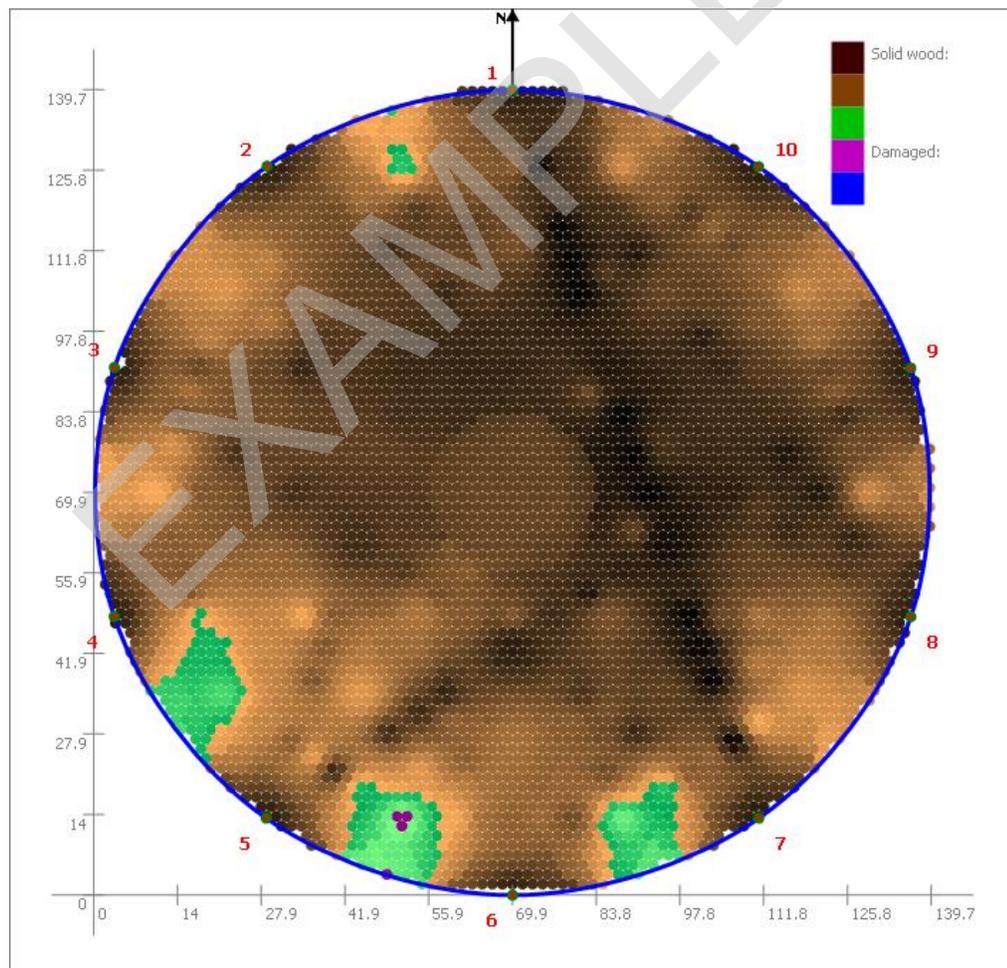
Figure 1:
Showing the tomogram taken at approximately 300mm above ground level

4.4 This tomogram suggests that there is a good correlation between the solid percussion sound testing and the lack of any significant decayed wood tissue indicated on the tomogram.

4.5 It also suggests that there is a good correlation between the area where the wound is present (approximately between sensors 4 and 5) and an area of dysfunctional wood tissue with minor pockets of decay forming.

4.6 The tomogram suggests that the majority of the trunk has healthy wood tissue as indicated by the tanned and dark brown colour. The tanned colour, whilst this is considered to be solid or sound wood, it is perhaps not 100% and considered to be an area of reaction wood or interface between dysfunctional wood tissue and sound wood tissue.
